City Council Report

To: Mayor and City Council
From: David Martin, Director, City Planning
Subject: Request to Approve Plans to Restore and Rehabilitate the Historic Interior Lobby of the Former United States Post Office Building Located at 1248 5th Street, in Accordance with a Preservation Covenant Administered by the City Council

RESTORATION AND REHABILITATION OF HISTORIC LOBBY

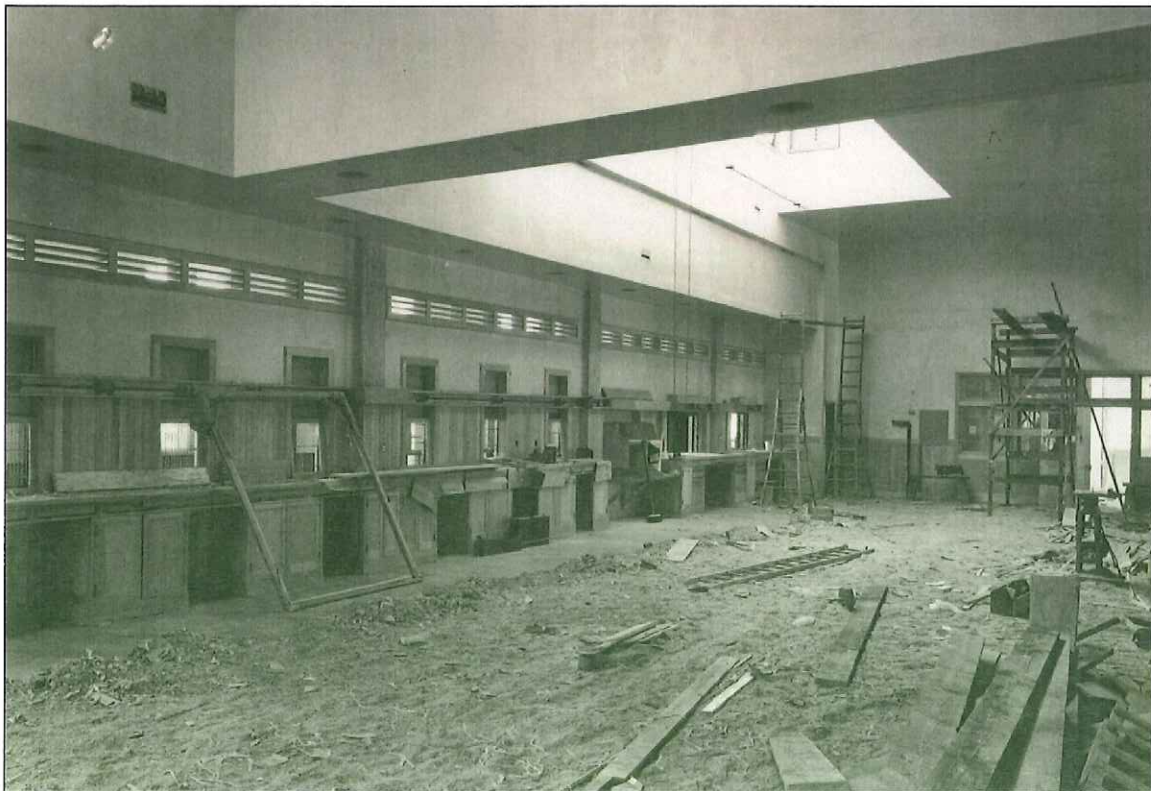
Image 2: Area behind lobby service desks under construction, skylights and lookout gallery above, looking southeast, 1937 (Santa Monica History Museum)

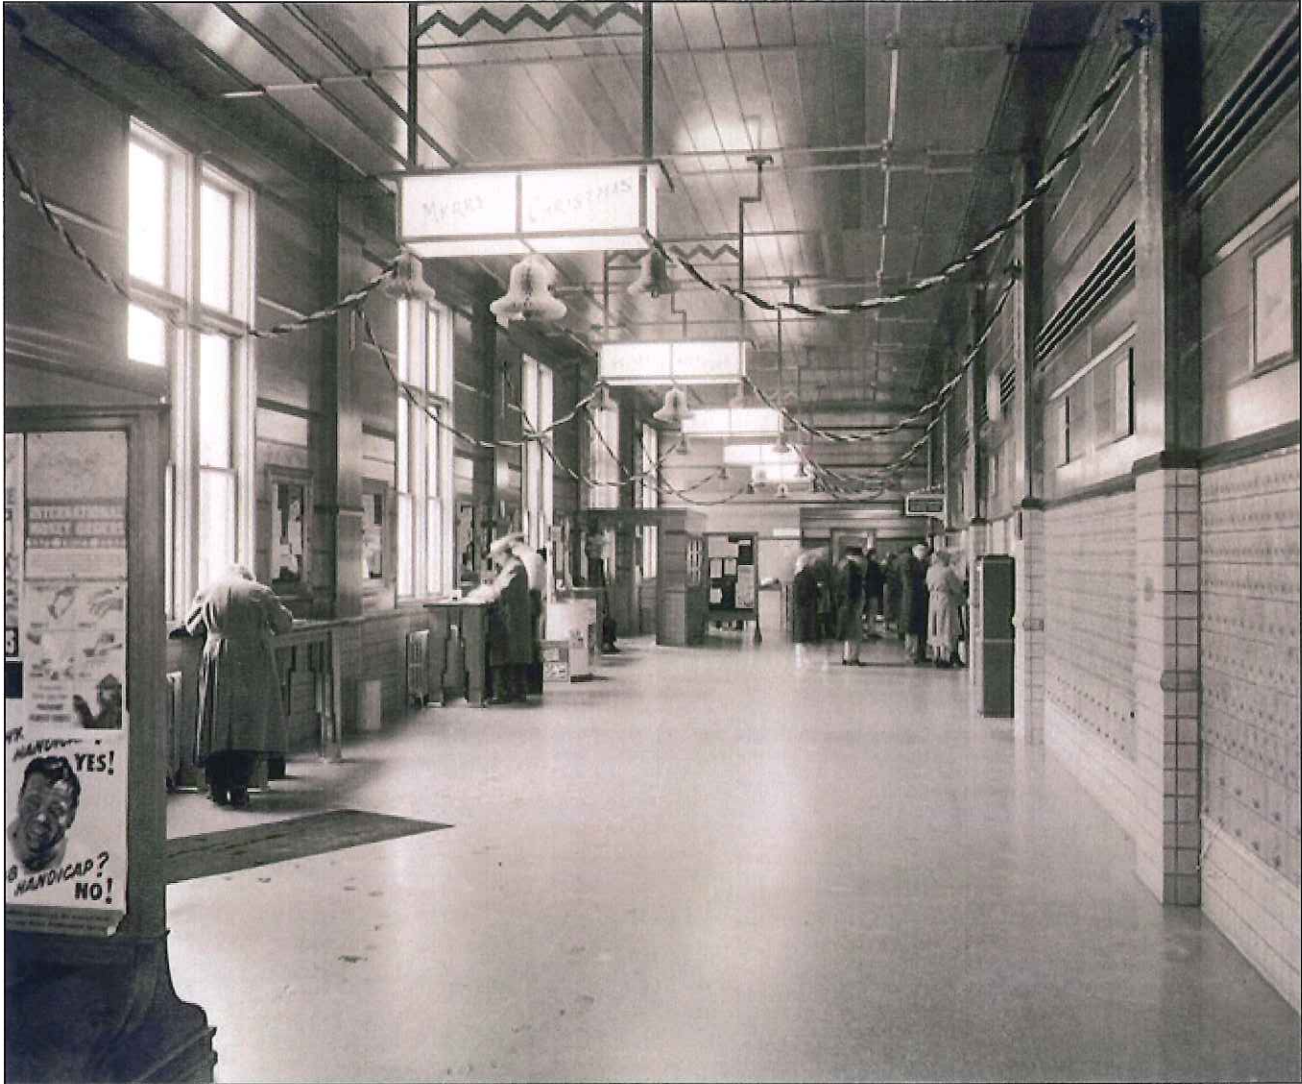
Image 3: Lobby with holiday decorations, looking south, 1949 (Santa Monica History Museum, Beebe Collection)

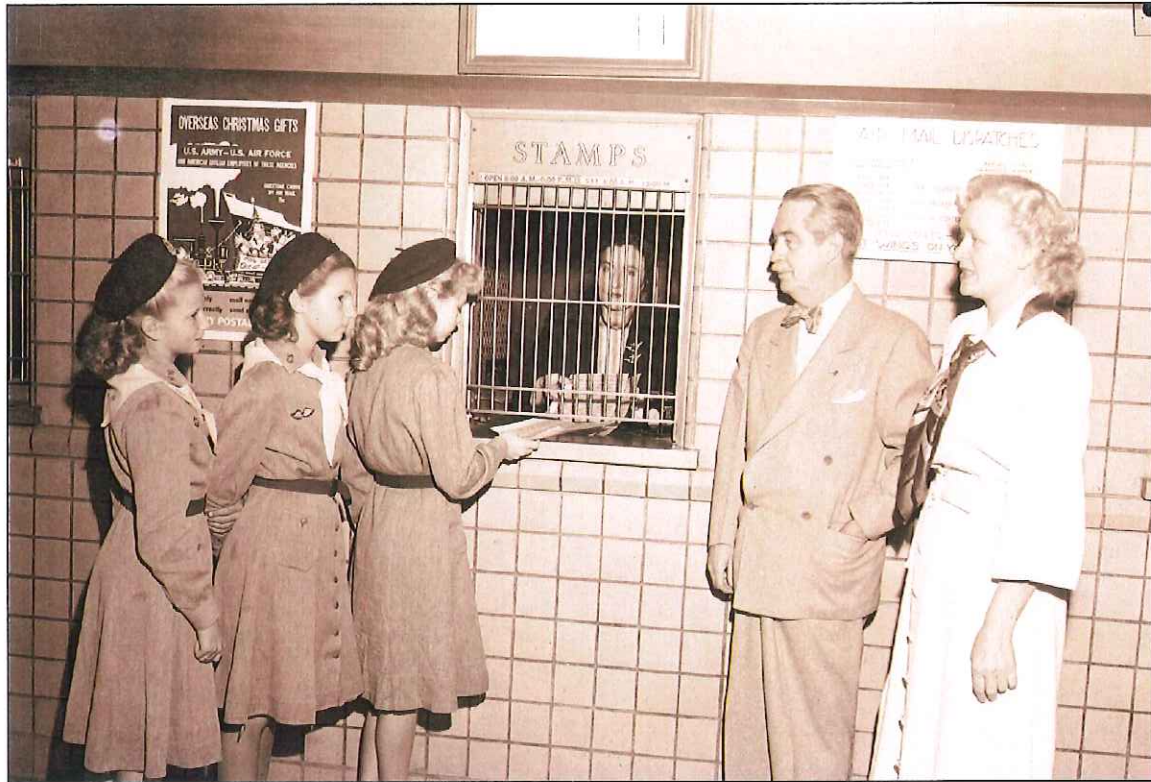
Image 4: Girl Scouts receiving commemorative stamps in lobby, 1948 (Santa Monica History Museum, Beebe Collection)

As part of the work, fenestration along the west wall would be reestablished with an interpretation of the original individual service windows. The new fenestration would generally, though not exactly, follow the historic sizes and pattern based on original drawings and early photographs (Image 4). The new windows would be comprised of clear glass interpreting the original service openings with signage panels above and painted surrounds and sills. Original window surrounds were constructed of wood and painted in a light color to match the tile wainscot; however, the reconstructed west interior wall would serve as fire separation between the lobby and office beyond, so reconstructed window surrounds would be framed in steel and painted grey to match the new limestone wainscot. Gold leaf lettering would be restored on the signage panels above each service window based on original drawings to read: Parcel Post, Stamps, General Delivery, Information, and Registry. In addition to the service windows, two sets of contemporary glazed and maple wood double doors would be constructed on the west wall to access the office beyond. New additions within the lobby, such as the contemporary double doors and partition wall, would be constructed in maple, differentiating the new doors and millwork from the original sugar pine walls. Numerous small surface mounted additions that have been installed along the west wall, including junction boxes and various patches, would be removed and patched.

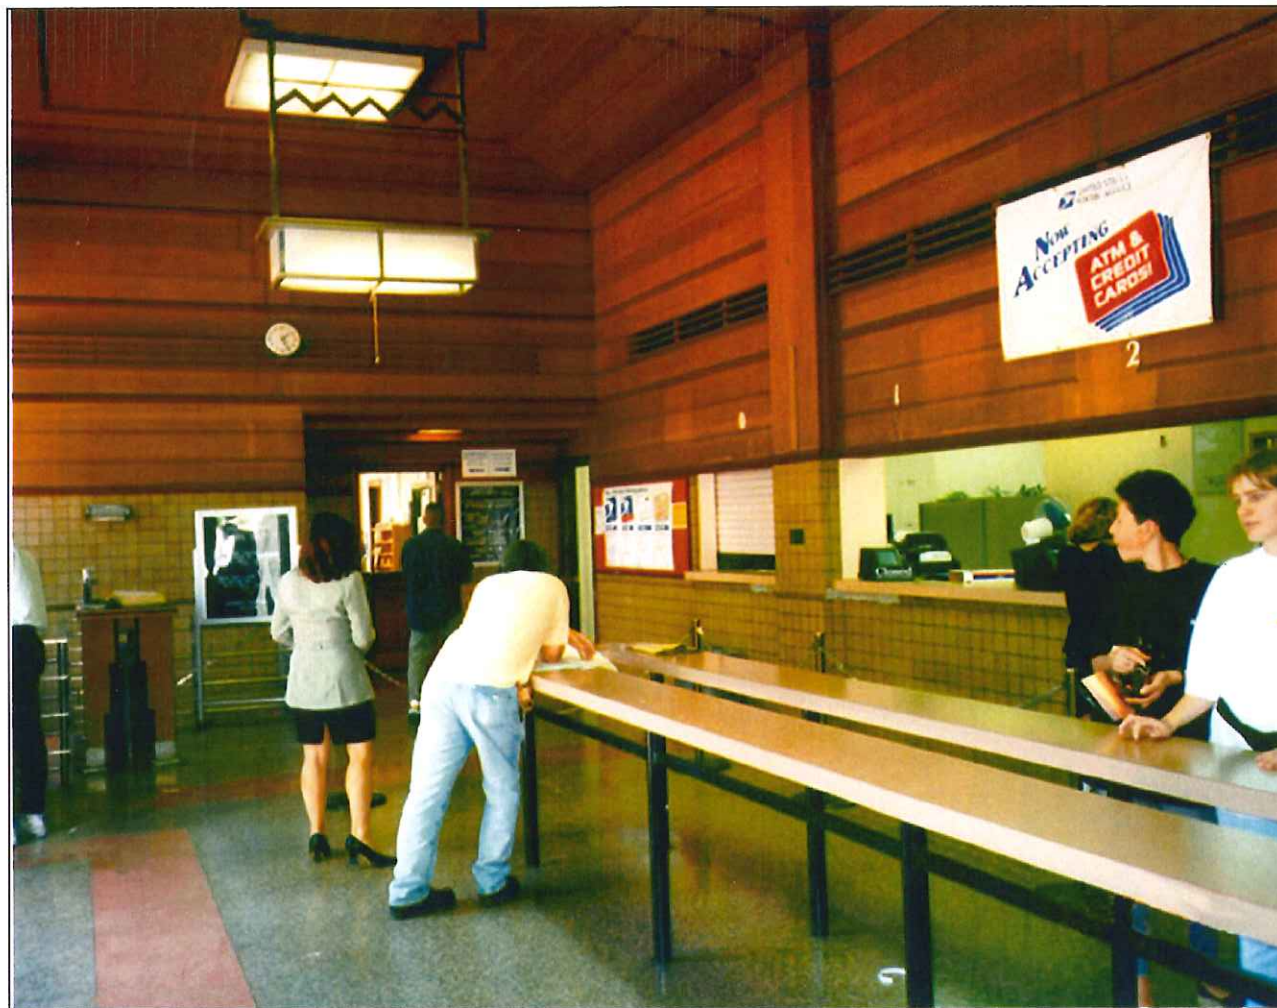
Image 6: Southern portion of lobby before renovation, looking south, circa 1990s (Rachlin Partners)

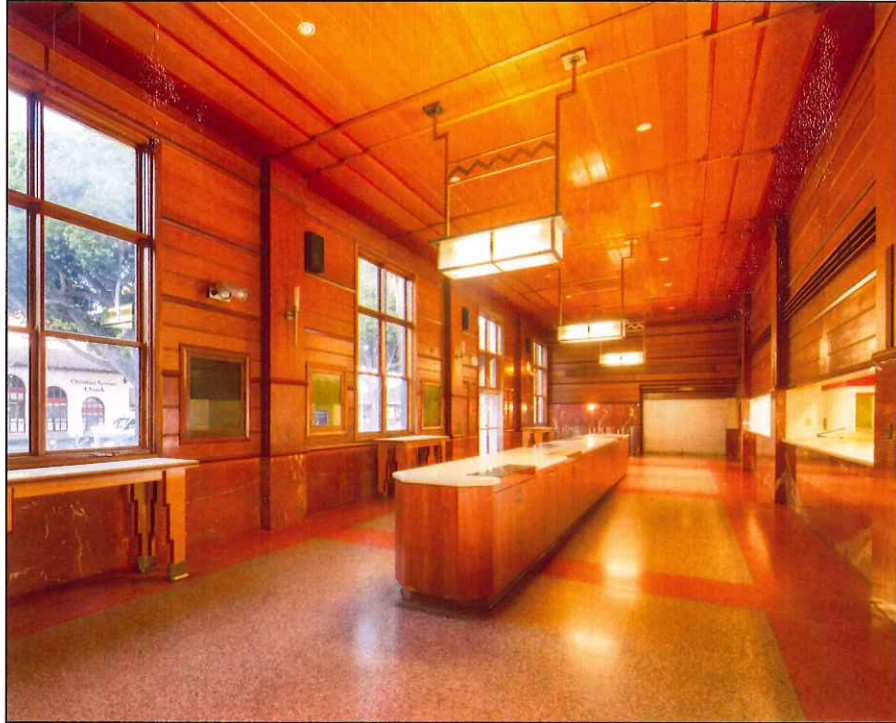
Image 7: Southern portion of lobby, looking south, Historic American Building Survey (HABS) digital field photographs (Schafer, 2016)

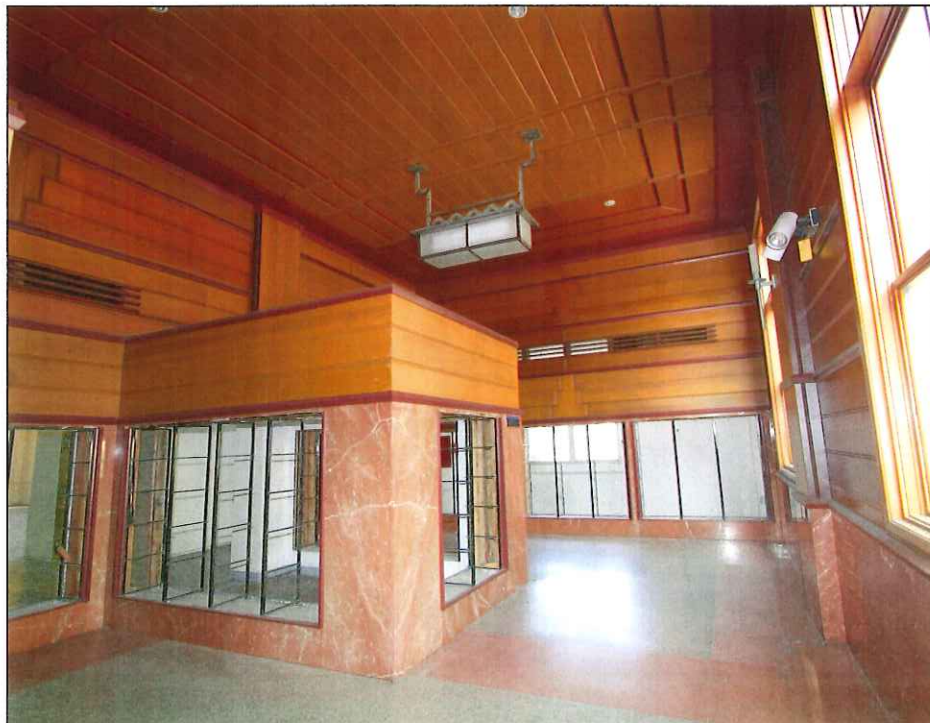
Image 10: Northern portion of lobby, looking north, added projecting postal box alcoves and altered north wall and truncated historic light fixture visible (Chattel, 2014)

The north wall originally contained four small individual service windows, similar to those found on the west wall. The wall was first altered in 1971 when individual service windows were replaced with a large opening for postal boxes and again when the north wall and ceiling were moved to make room for additional postal box alcoves, eliminating the office to the north (Image 29). It appears that the original north wall and ceiling cladding was reused in its current location.

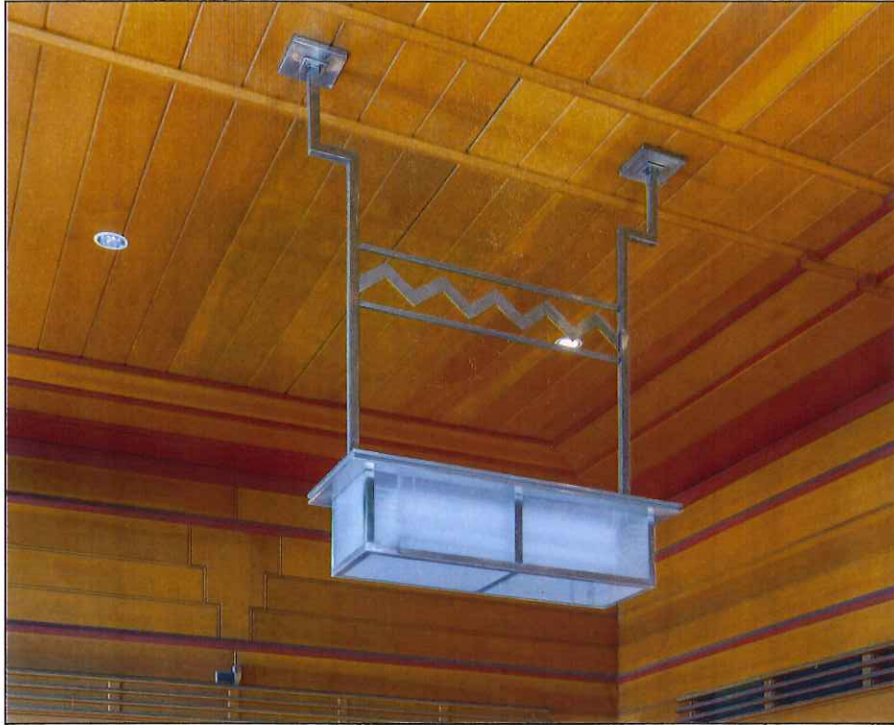
Image 11: Original stainless steel light fixture (Schafer, 2016)

The historic wood ceiling would remain in place and would be repaired and treated in the same way as the historic wood walls. The six historic pendant light fixtures would be re-lamped and restored to original sizes (where previously truncated). Any canned lighting will be removed.

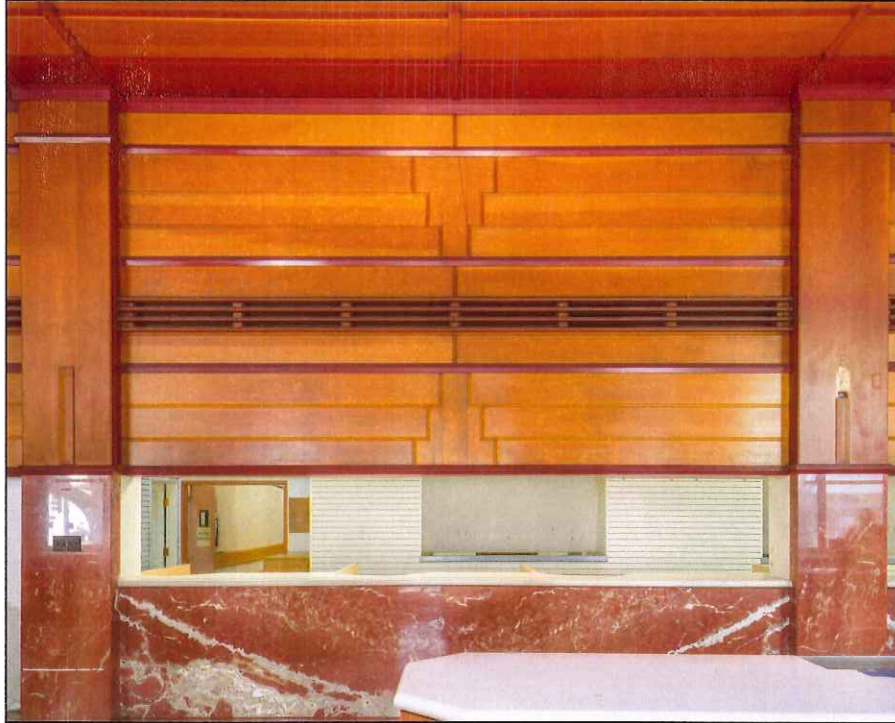
Image 13: Southern portion of lobby, detail of open service counter bay with Streamline inspired vents above (Schafer, 2016)

The west wall has been extensively altered since construction. Originally the west wall was lined with small individual service windows, mail drops, and postal boxes. Individual service windows in the southern portion were removed creating long service counters between pilasters (Image 13). In the northern portion of the lobby, additional service windows and original postal boxes were removed and replaced with four projecting alcoves to accommodate supplementary postal boxes. All postal boxes were removed by the postal service in 2013.

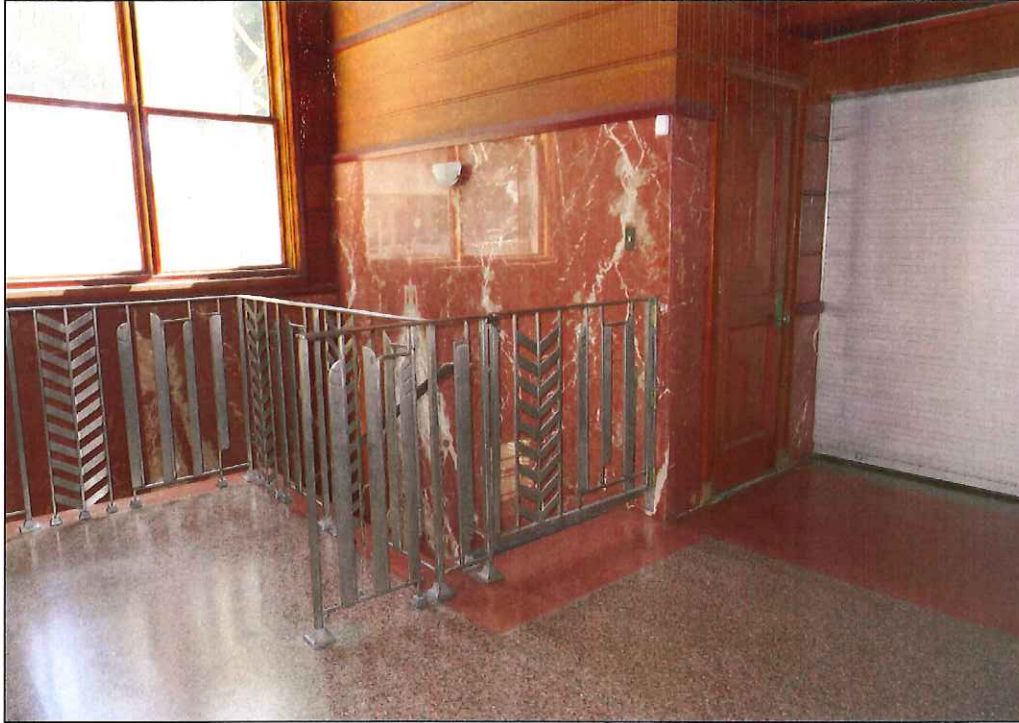
Image 15: South wall recess with door to janitor's closet, south wall opening and basement stair (Chattel, 2016)

The south wall has a recess that originally contained three doors, two of which remain. One accesses a janitor closet and another provided access to offices, and now provides access to the work room. At some point (likely in the 1990s), the offices south of the lobby were reconfigured as additional retail space and the third office door and wall were replaced with a counter covered by a metal roll up door. Adjacent to the south wall recess is a terrazzo-clad staircase that accesses the basement. A simple stainless steel railing surrounding the stair was replaced during a 1990s renovation with the current decorative railing which closely matches the historic exterior railings. An original stainless steel handrail curves around the interior stair wall (Image 12). A wall sconce on the south wall above the stair was replaced with a contemporary sconce at unknown date.

The work would remove the large opening and counter at the south wall recess and infill the opening with a new wood frame and glazed double door, which would access a pantry off the commissary. The space within the janitor's closet would be utilized by the pantry behind; however, the original wood door would be fixed in place. Marble wainscoting at the stair would be removed and replaced with limestone, and the original handrail would be reinstalled in the same location.

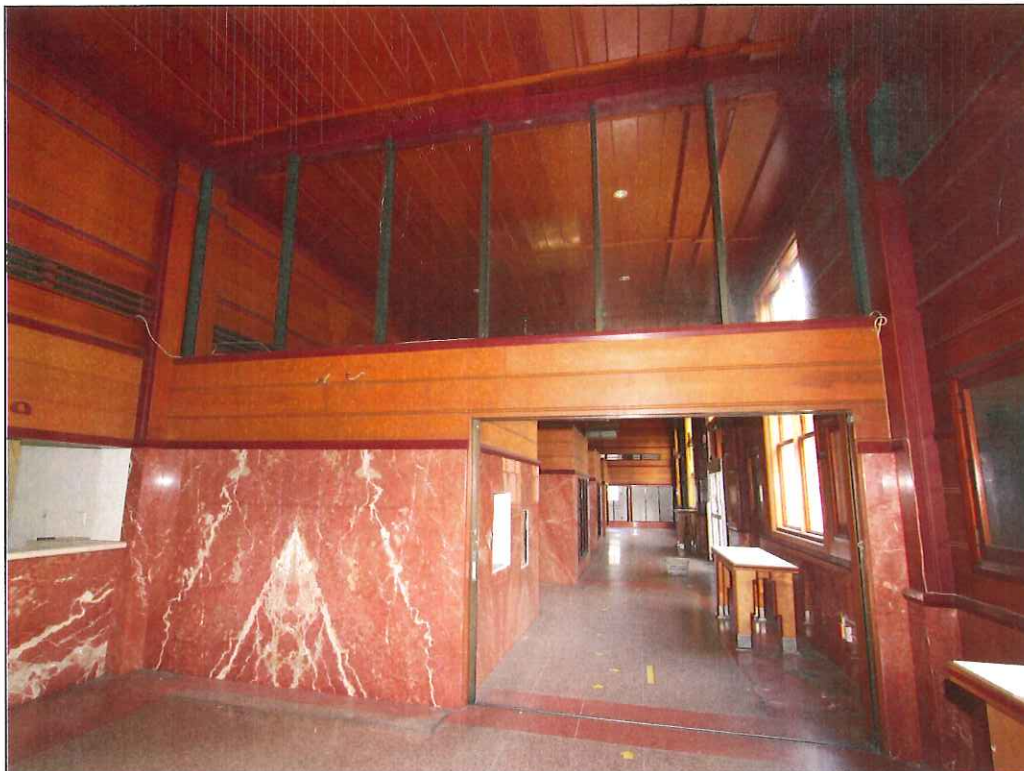
Image 17: Non-historic partition wall separating lobby into southern and northern portions (Chattel, 2014)

As a result of various alterations over time, the lobby has been expanded and divided into two distinct spaces by a non-original partition wall (Image 16). The northern portion consists of alcoves/projections formerly containing postal boxes and the southern portion consists of retail service counters. At the southern end of the lobby, a set of L-shaped terrazzo stairs provide access to the basement (Image 15). The stairs are surrounded by a non-historic stainless steel railing designed to closely match exterior railings, and an original stainless steel handrail curves down the inside wall.

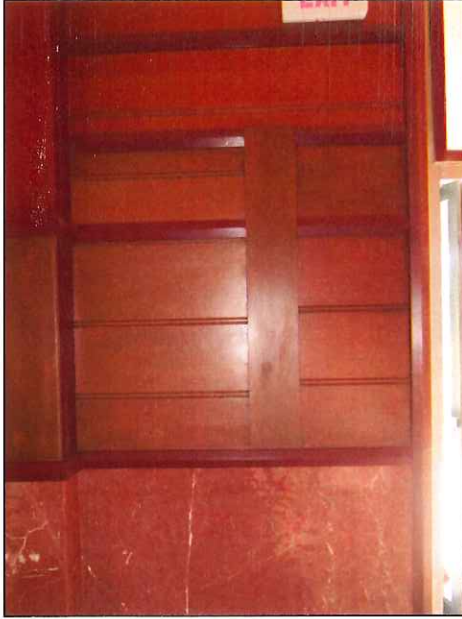
Image 19: Existing wall conditions - Wood patch added where entry vestibule removed from south entrance (Chattel, 2016)

Alterations through the years have left holes and other signs of damage to the wood boards. Following removal of non-historic alterations, holes would be patched or wood boards would be

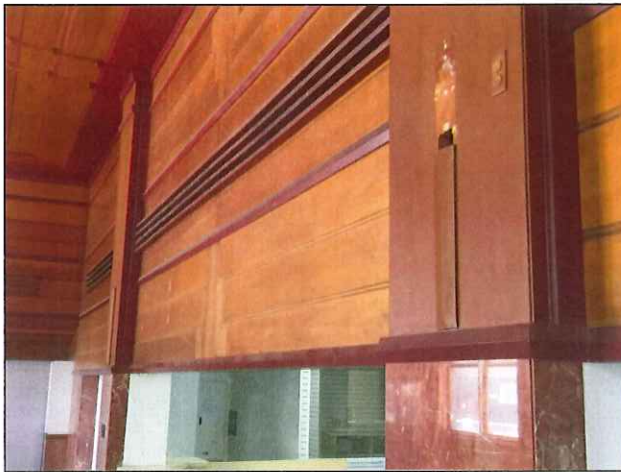
Image 20: Existing wall conditions - Wood patch added where flange signs removed on west wall pilaster (Waisler, 2016)

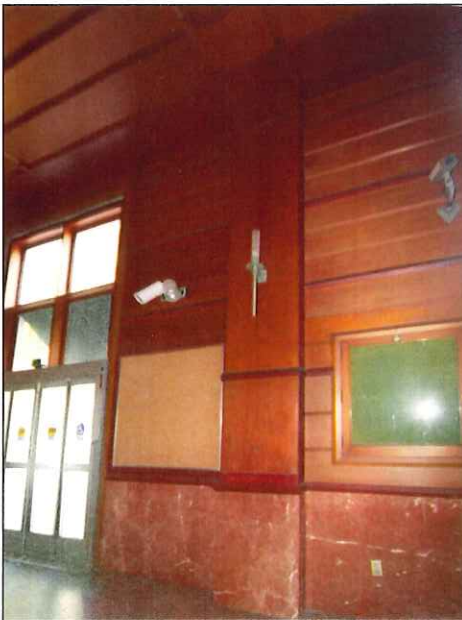
Image 21: Existing wall conditions - Surface mounted additions on east wall (Chattel, 2014)

The east wall is generally intact. Numerous small surface mounted additions have been installed along the east wall including sconce light fixtures on the pilasters, exit signs, emergency lights, speakers, security cameras, other repairs surrounding entrances where vestibules were removed.

The proposed work would remove surface mounted additions and patch and repair walls as necessary. Though deteriorated, a few bulletin boards maintain original signage with gold leaf

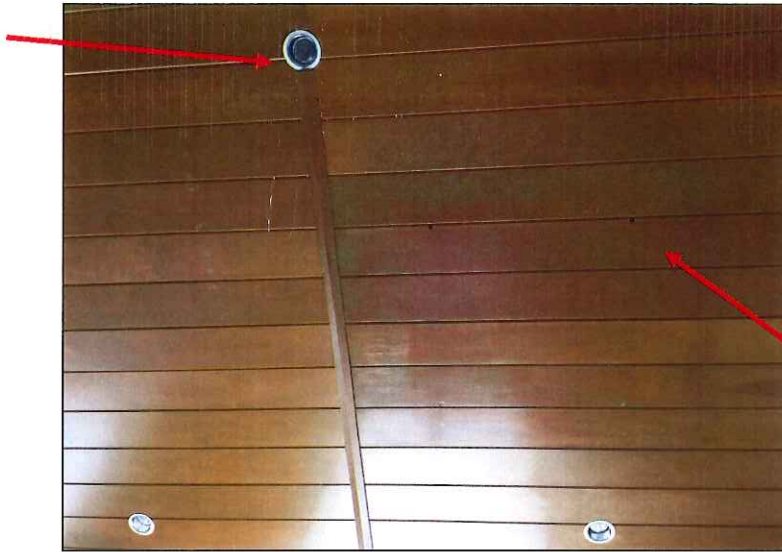
Image 22: Existing ceiling conditions - Recessed 5 inch can lights that cut through wood boards and trim. Holes visible from past ceiling mounted light fixtures (Waisler, 2016)

The wood at the ceiling would be treated in the same way as the walls. The ceiling currently displays damage, including discoloration and mounting holes, from past ceiling mounted four-foot square light fixtures added in 1964 and since removed. Additions to ceiling above expanded northern portion would be removed and ceiling would be reconstructed in the original location using historic material to the extent feasible.

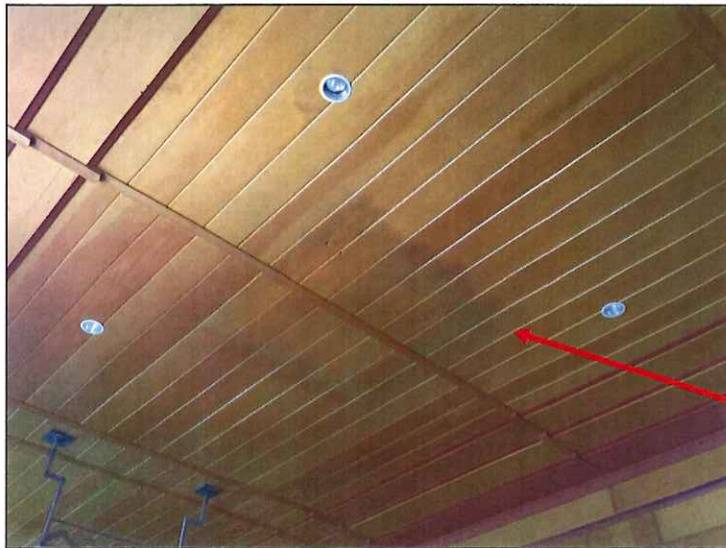
Image 23: Existing ceiling conditions - Staining from past ceiling mounted light fixtures (Waisler, 2016)

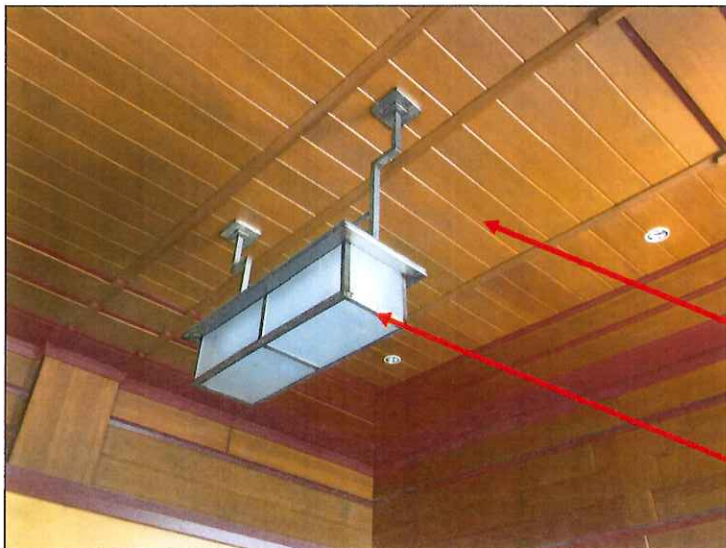
Image 24: Existing ceiling conditions - Added boards where north lobby wall moved and truncated historic light fixture (Waisler, 2016)

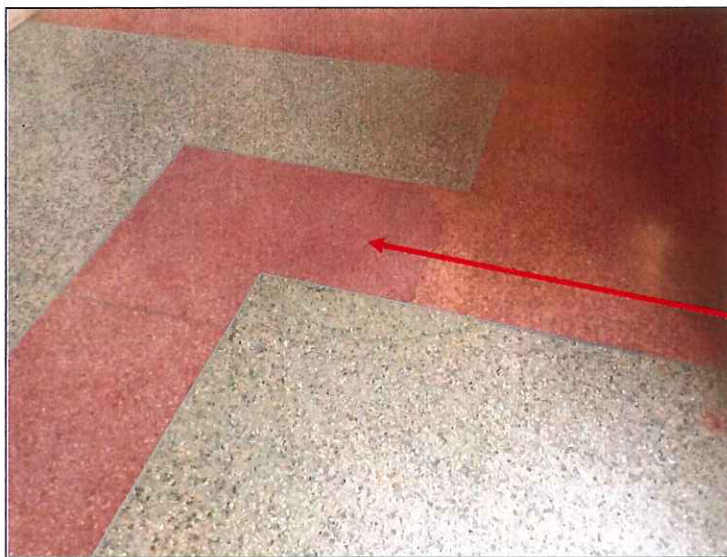
Image 25: Existing floor conditions - Incompatible terrazzo patch (Waisler, 2016)

The existing terrazzo lobby floors will be retained, repaired, cleaned and treated with an application of a new protective clear coating.

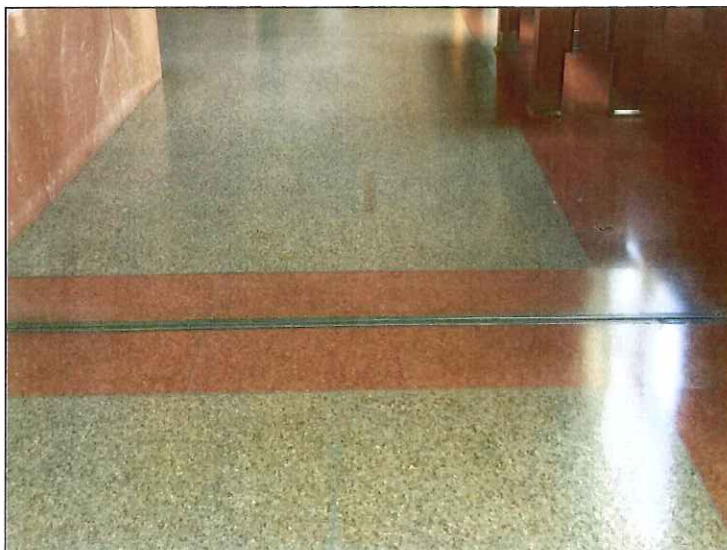
Image 27: Existing floor conditions - Channel through terrazzo border at existing dividing wall (Waisler, 2016)

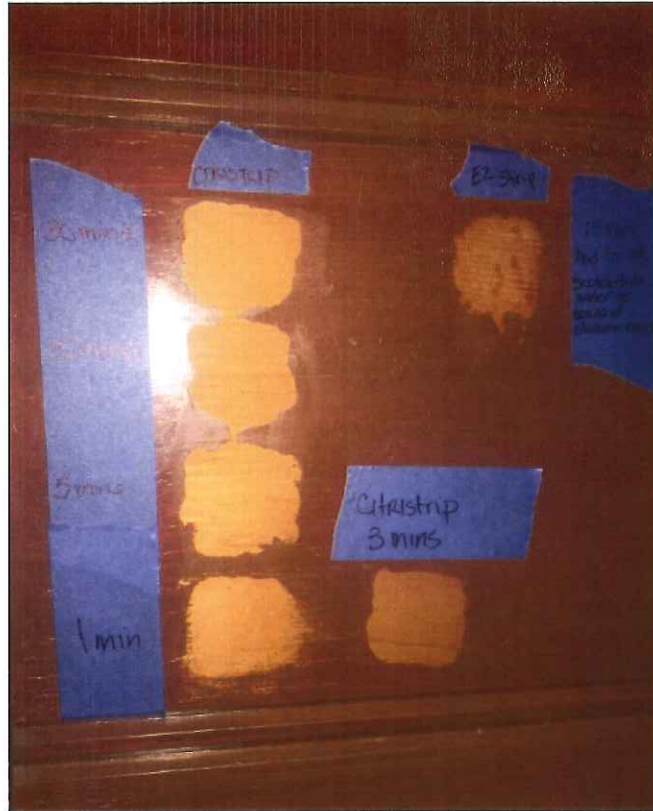
Image 28: Test samples of coating removal treatments showing exposed sugar pine wood cladding following removal of existing discolored clear coatings (Biddle, 2016)

The wood in the lobby was originally coated in clear shellac and the trim had a reddish-brown stain covered by the same clear coating. In accordance with the conservator's recommendations, the proposed treatment of the historic wood cladding would include removal of coating build-up using a chemical application, cleaning of wood, and application of a new clear coating. An oil based stain, matched to the color of the trim, would be used as necessary. Testing and field trials of removal, cleaning and coating treatments are underway to identify the gentlest effective method (Image 28).

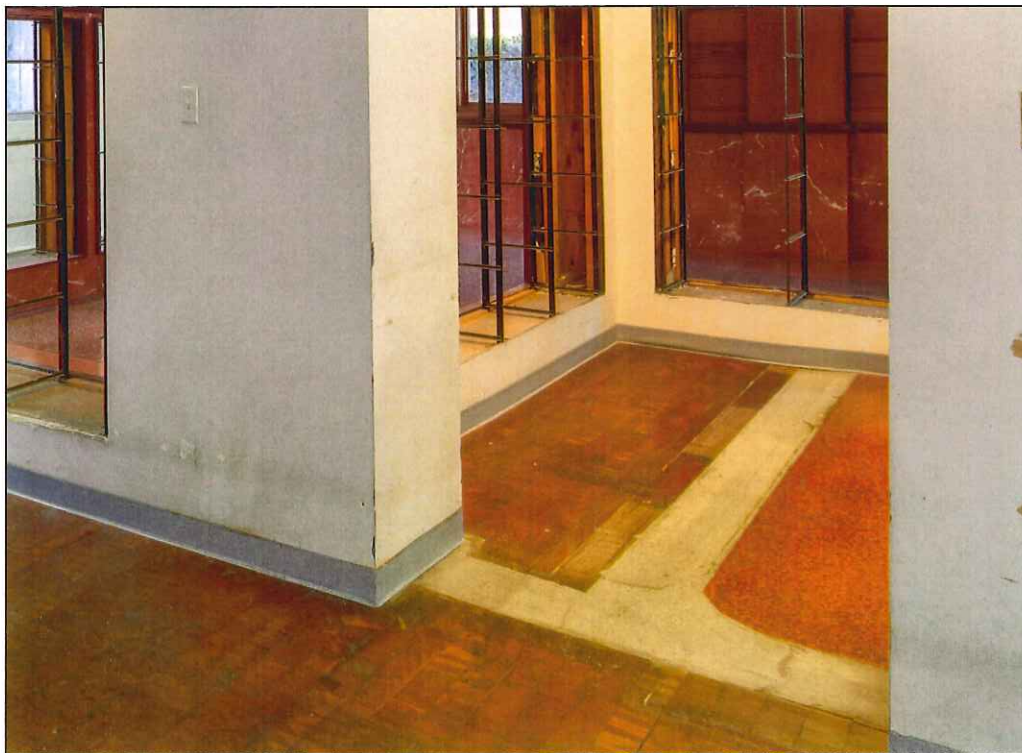
Image 29: View of lobby flooring from inside workroom, looking east. Image shows original location of lobby north wall (where salmon color terrazzo flooring is visible) and north office (where end grain wood block flooring is visible) (Schafer, 2016)

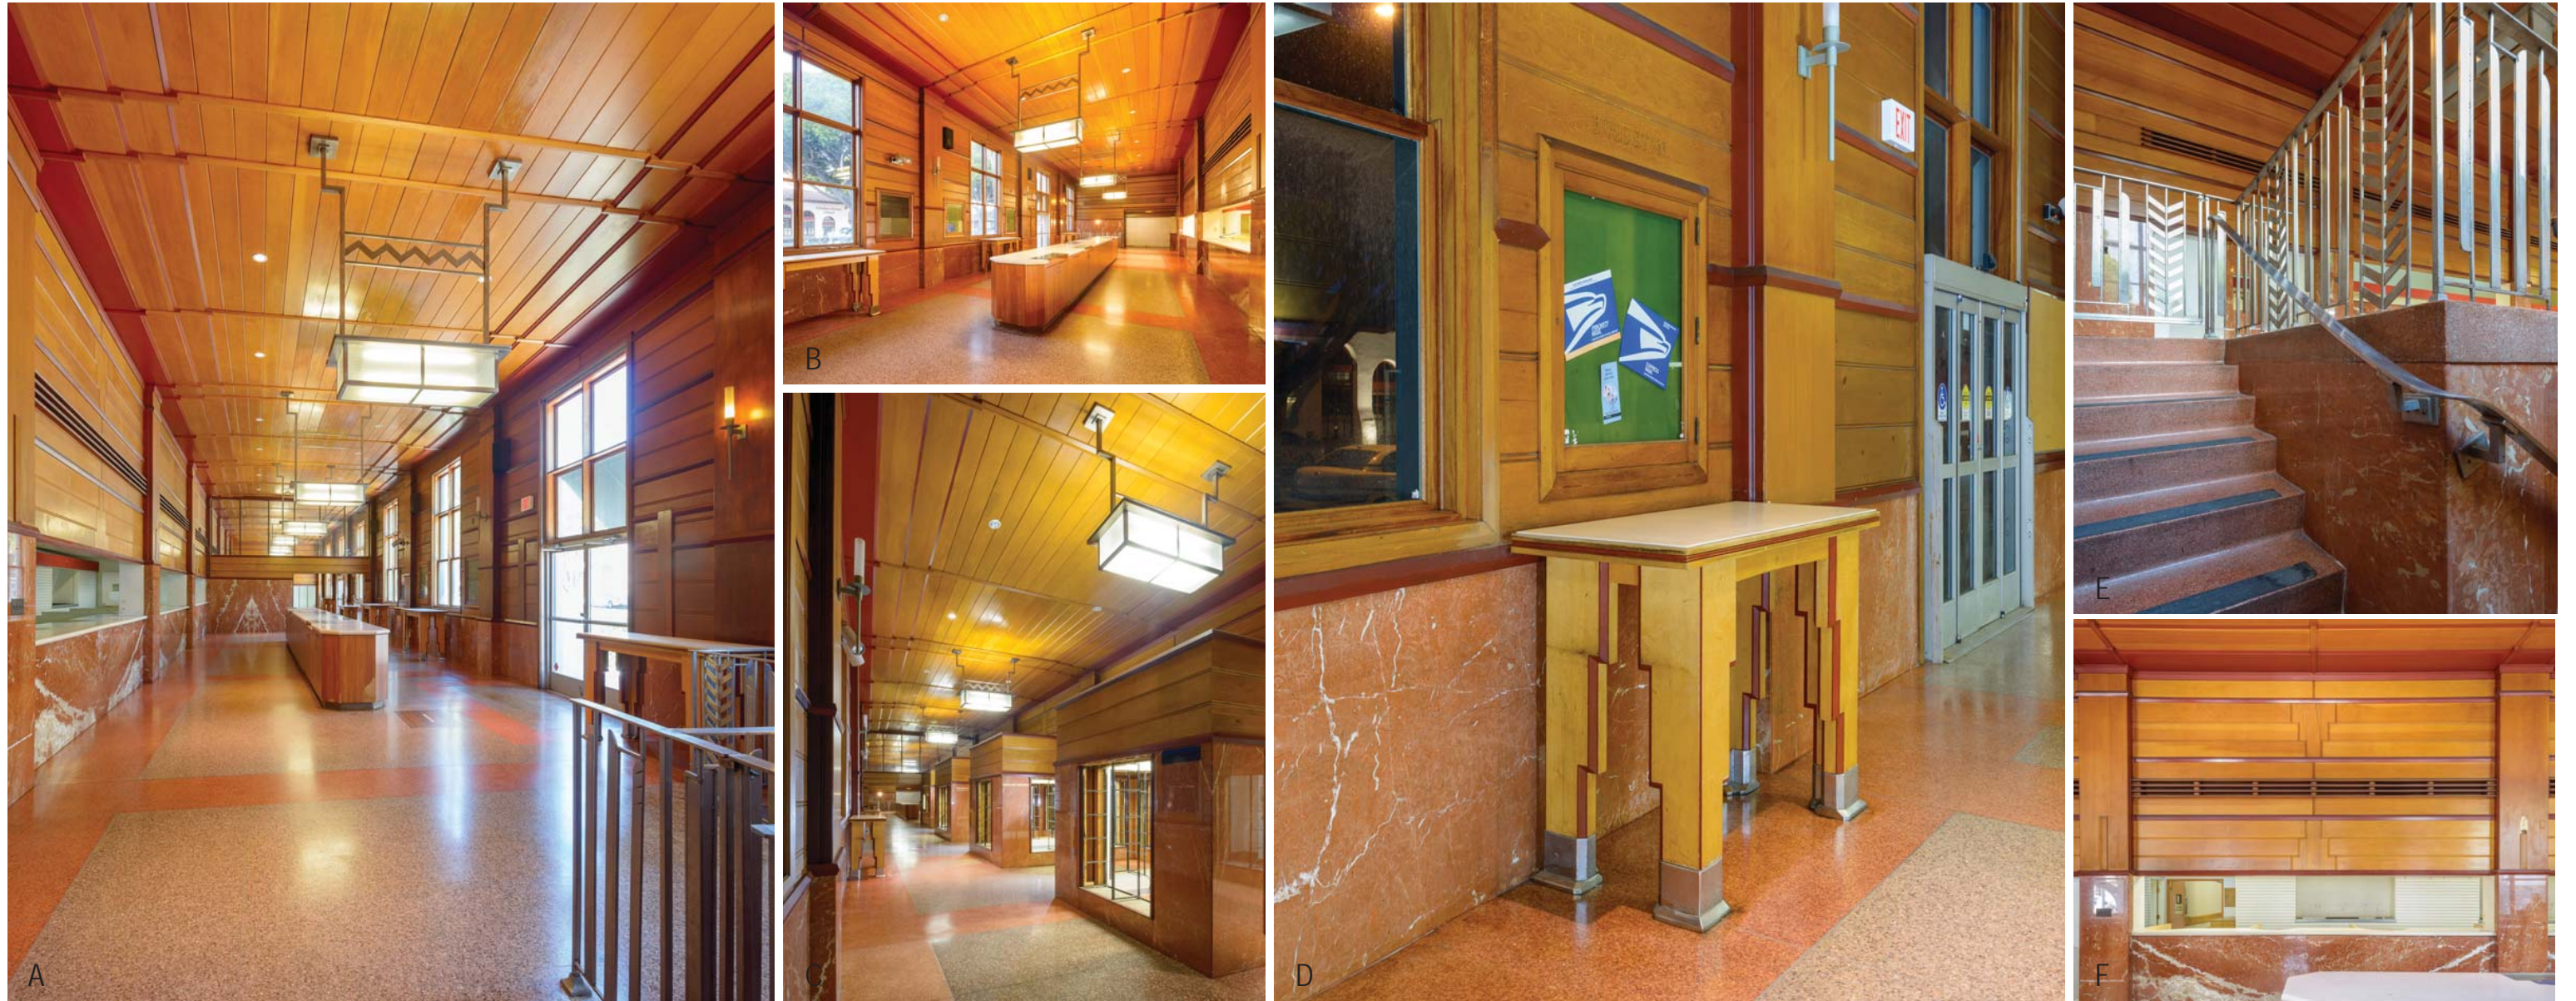
A. Southern portion of lobby with service counters, looking North.
 B. Southern portion of lobby, looking South.
 C. Northern portion of lobby with postal box alcoves, looking South.
 D. Historic lobby table and bulletin board
 E. Terrazzo stairs, curved stainless steel handrail and railing from landing
 F. Detail of Lobby service counter bay

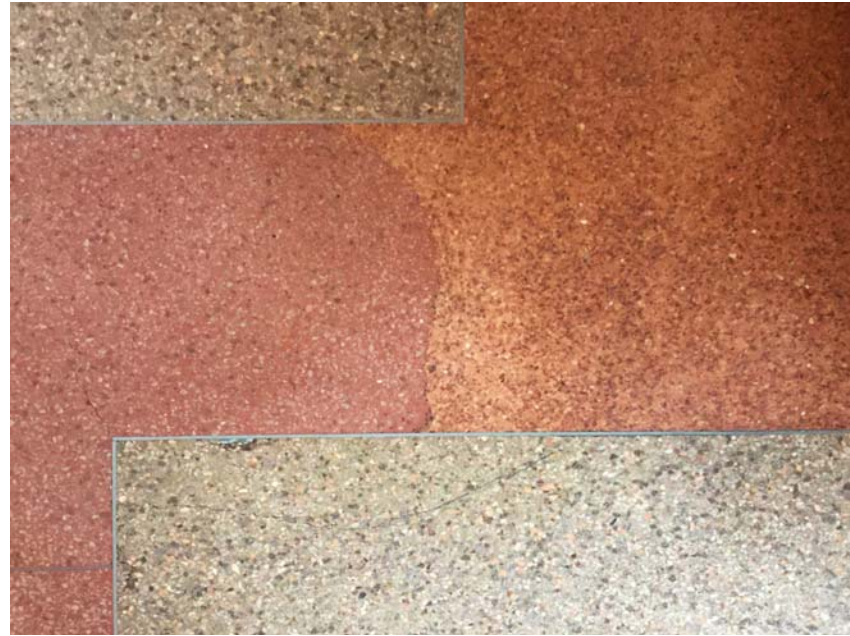
Terrazzo patch at location of former entry vestibule

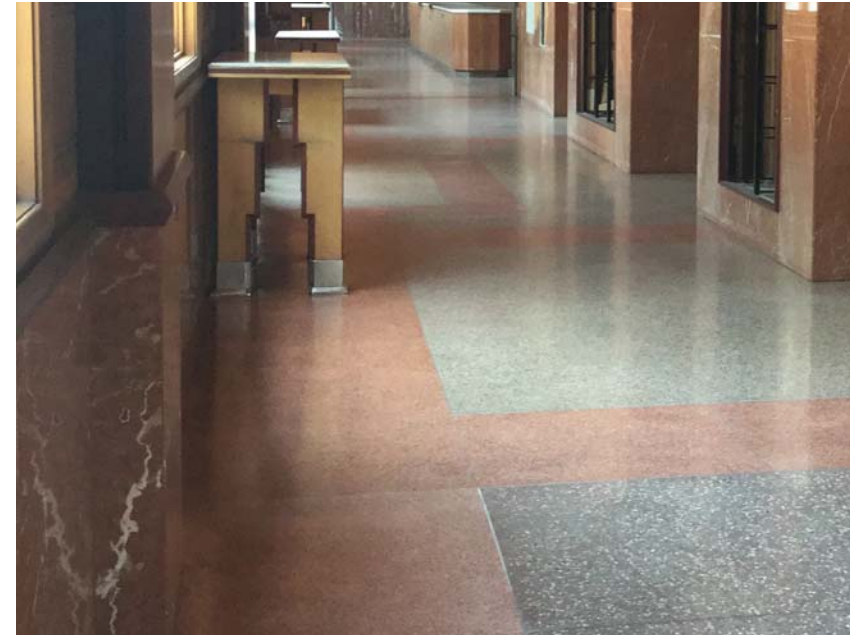
Differing terrazzo colors where lobby has been expanded
